# Manhole Inspection Summary

Manhole # S25GG\_050MH

Insp Date: **9/10/07 10:25 AM**

**Location** Address: **1913 BRUNT ST**

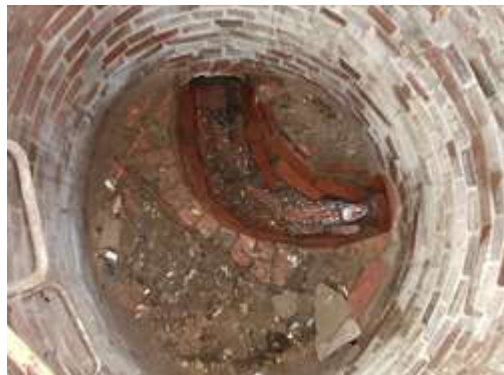
Top View

Bench debris.

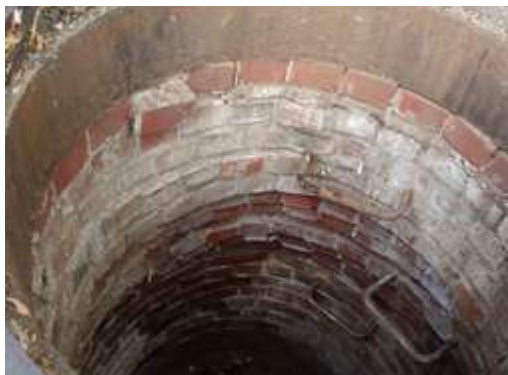
Defect

**Frame** Offset: **1** (in.) Condition: ☐ Sound ☐ Cracked ☒ **Leaks**

Condition: ☐ Sound ☐ Cracked ☐ Root Intrusion ☒ **Loose Brick** ☒ **Deteriorated**

Infiltration: ☐ None ☒ **Joint** ☐ Cracks ☒ **Mortar** ☐ Roots ☐ Wall

Frame leaks. Adjustment deterioration and infiltration. Corbel and Barrel infiltration.

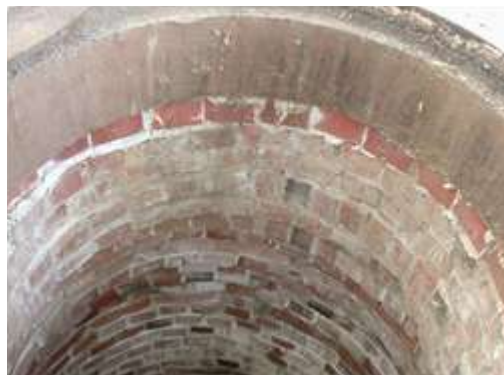
Defect

Frame leaks. Adjustment deterioration and infiltration. Corbel and Barrel infiltration - other side.

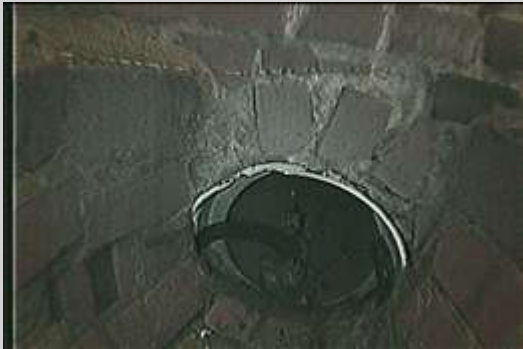
### 8 in. Circular Gravity Sewer Pipe Out @ 12 O'Clock

Infiltration: **Evidence** Pipe Seal Cond: **Unknown**
